# Snag Analysis

Affected Part: **AC - Pilatus - PC12 - AIS**

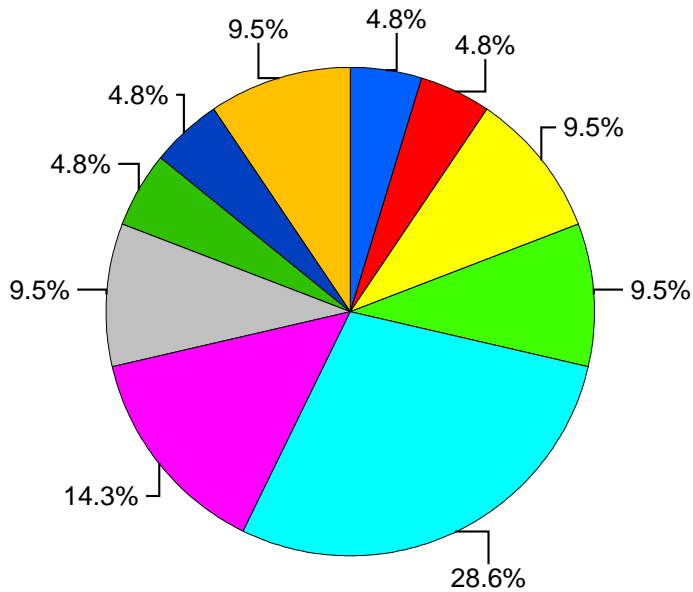
## ATA Breakdown

10x	4.8%
21x	4.8%
23x	9.5%
24x	9.5%
25x	28.6%
32x	14.3%
33x	9.5%
52x	4.8%
79x	4.8%
ACx	9.5%
Total: 100.0%
